Manhole Inspection Summary

Manhole # S55K__065MH

Insp Date: **5/30/08 9:04 AM**

Location Address: **102 fagley**

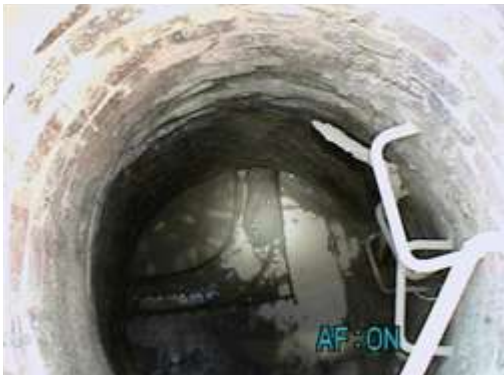
Miscellaneous

steps

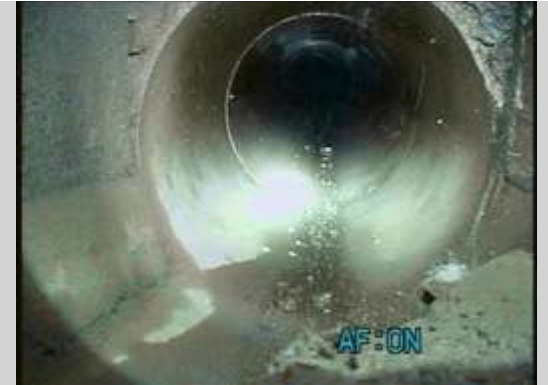
12 O'Clock Outflow

8 in. Circular Gravity Sewer
Pipe Out @ 12 O'Clock

Pipe Material: **Clay** ☐ Pipe Lined

Invert Depth: **9.60** (ft.) Flow Characteristics: **None**

Deposits: ☒ None ☐ Mud ☐ Sludge ☐ Debris ☐ Grease

Infiltration: **None** Pipe Seal Cond: **Unknown**

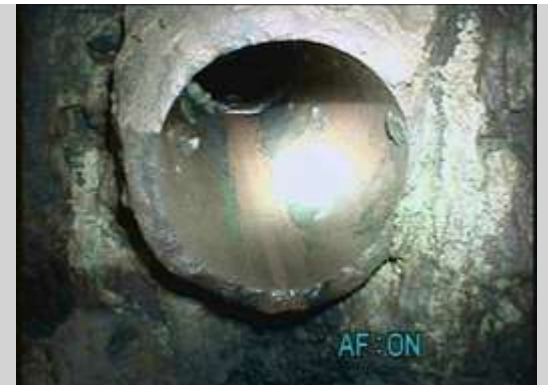
8 O'Clock Inflow

8 in. Circular Gravity Sewer
Pipe In @ 8 O'Clock

Pipe Material: **Clay** ☐ Pipe Lined

Invert Depth: **8.40** (ft.) Flow Characteristics: **Slow**

Deposits: ☒ None ☐ Mud ☐ Sludge ☐ Debris ☐ Grease

Infiltration: **None** Pipe Seal Cond: **Unknown**

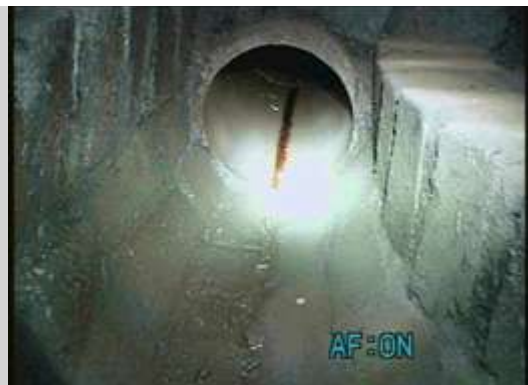
9 O'Clock Inflow

8 in. Circular Gravity Sewer
Pipe In @ 9 O'Clock

Pipe Material: **Clay** ☐ Pipe Lined

Invert Depth: **9.20** (ft.) Flow Characteristics: **Slow**

Deposits: ☒ None ☐ Mud ☐ Sludge ☐ Debris ☐ Grease

Infiltration: **None**
